Repair Hints

Service-Level 3 & 4

1100

RH-18

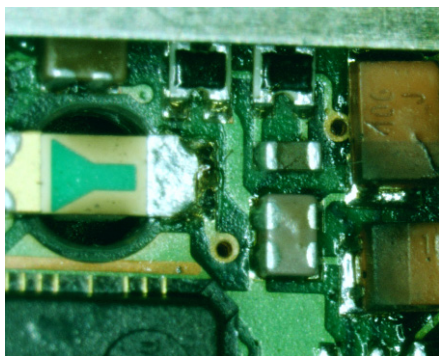
"rework" done with uncontrolled hot air

All replaceable (not underfilled) μ BGA components must be renewed after removing. Reflow with uncontrolled hot-air fan is strictly forbidden! It is also not recommended only to reflow the old μ BGA using a μ BGA rework station! μ BGA must only be soldered with NMP approved μ BGA rework machines (e.g. Zevac/ OK-Metcal/ Martin) to get durable solder joints.

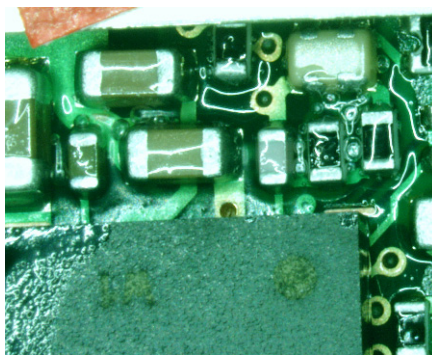
PWB drowned in flux

Use only recommended flux type and an appropriate amount of it – avoid drowning the PWB in flux as this will lead to additional faults!

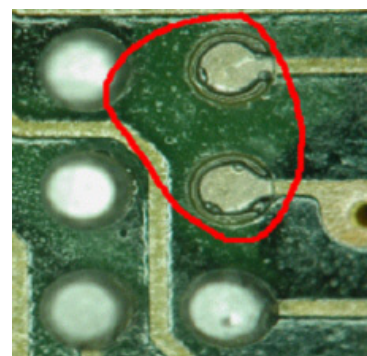
oxidated soldering

After removing a μ BGA check soldering points; if necessary rework oxidated solderings (broken balls) carefully by tinsplating these areas with few flux and a hot soldering iron. Before placing a new component remove the tin and clean the PWB; e.g. with help of solder wick and flux cleaner such as "Kontakt LR".

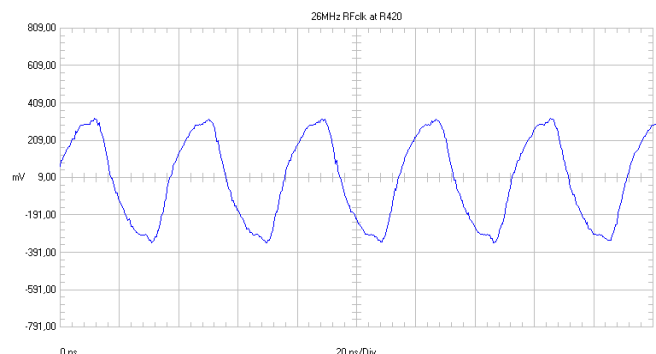
Figure 1: 26MHz RF clock at R420

Check 26MHz reference clock at R420. Check the signal of the SHF-oscillator directly; but you can check the control voltage at C641: if this voltage is outside its normal range (0.7VDC – 3.8VDC) this indicates that the oscillator probably is faulty or the control loop is open. Further more check ResetX_Mjoelner at J424, which normally is 1.8VDC.

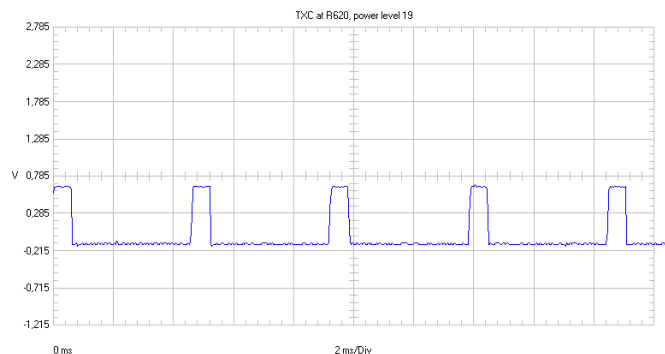
Figure 2: TXC at R620, power level 19

Check with an oscilloscope TXC at R620 (0.5Vpp – 1.2Vpp depending on TX power level):

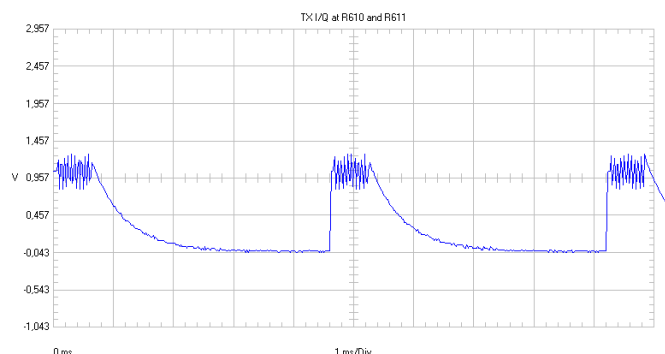
Figure 4: TX I/Q at R610 and R611

Check TXP 1.8Vpp at C646 and TX I/Q - signals at both sides of R610 and R611:

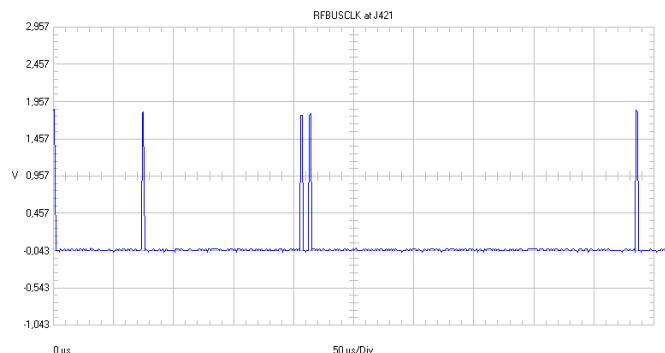
Figure 6: RFBUSclk at J421

Also check with an oscilloscope RFBUSclk at J421, RFBUSData at J422 and RFBUSEN at J423:

If all these signals are ok but no TX-signal is measurable at L606 in GSM900 mode and at L613 in GSM1800 mode, Mjoelner N600 is faulty in all probability.

Swap the phone because Mjoelner is underfilled and therefore not changeable.

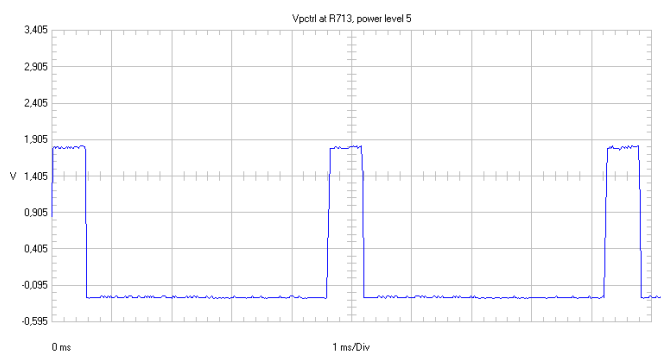
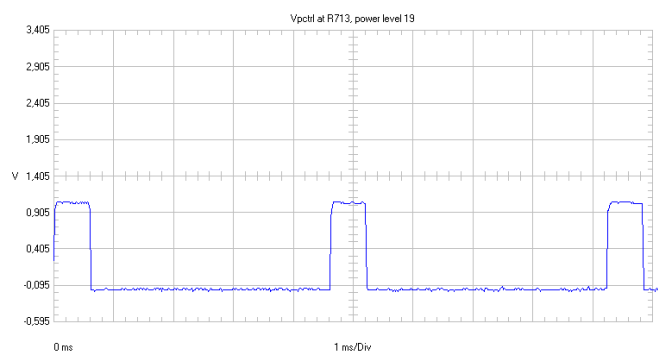
Figure 9: VPCRLT at R713 for power level 5 and 19

Check VPCTRL 1.2Vpp – 2.2Vpp dependent on TX power level at R713 in GSM900 mode and at R708 in GSM1800 mode.

If the VPCRLT-signal at the amplifier's input at R713 in GSM900 mode and at R713 in GSM1800 mode above mentioned is ok but still there is no or too low TX power at the output of the amplifier, it is necessary to exchange the N700.

Remember to perform RF-calibrations after exchanging the power amplifier!!!
