Repair Hints

Service-Level 3 & 4

1100

RH-18

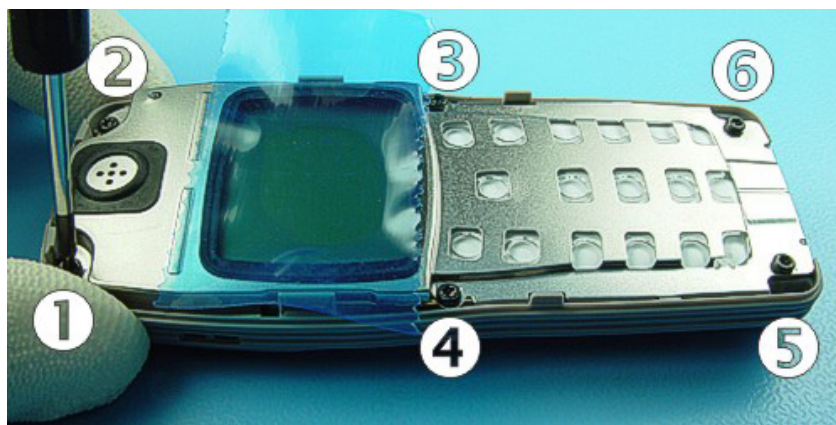
Disassembling (1-6) and assembling (6-1) order

To tighten screws only use a torque screwdriver with a torque adjusted to **21Ncm**. Notice assembling: take reverse order to the one shown in the picture below!
